MICROCRACKS AND METALLIZATION BURNOUT

Armen E. Mardiguian

September 1979

Final Report

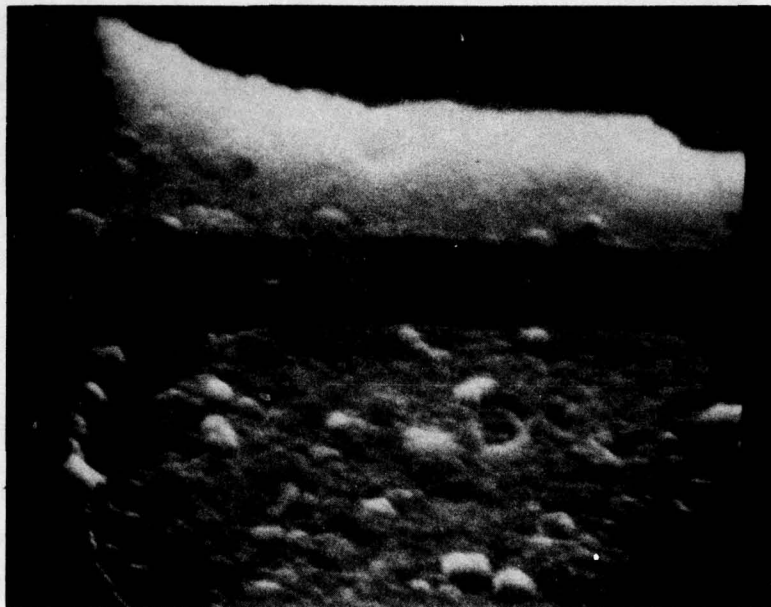
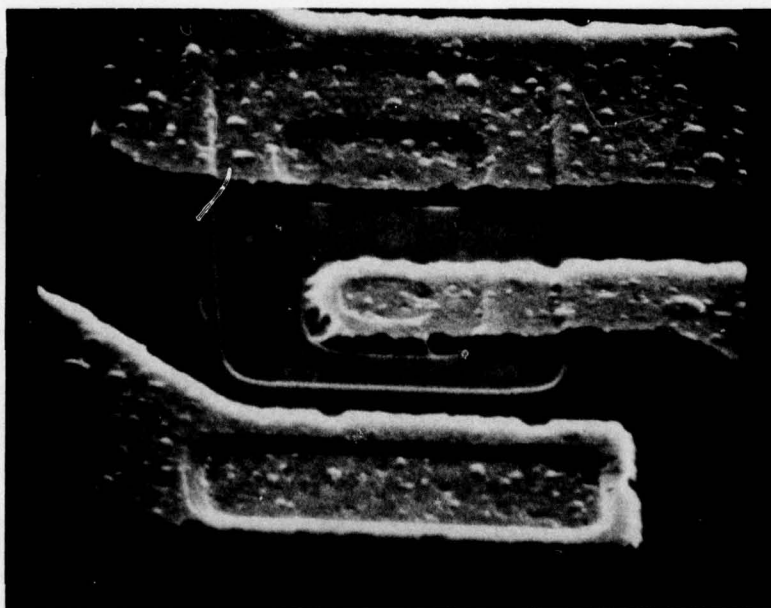
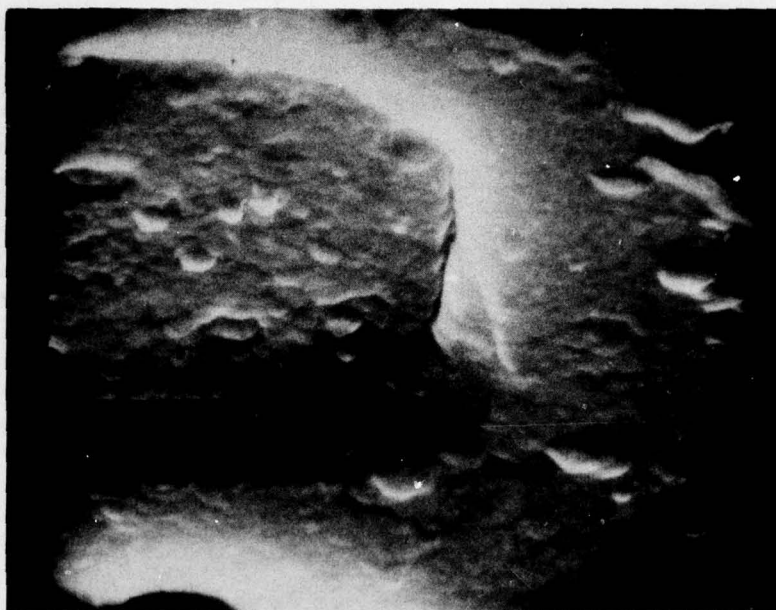
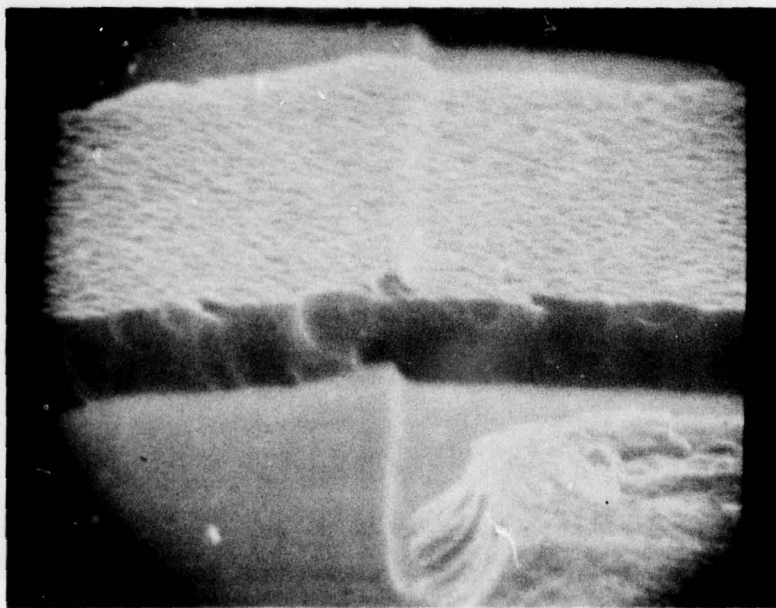
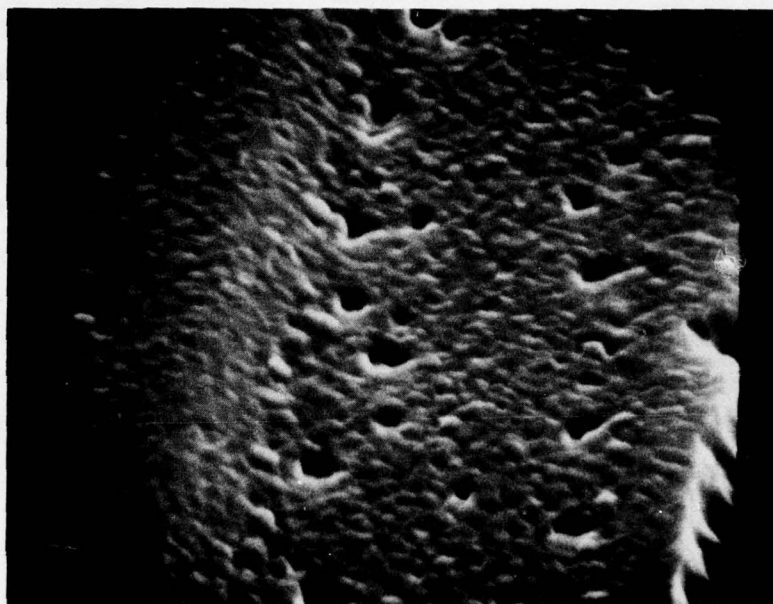
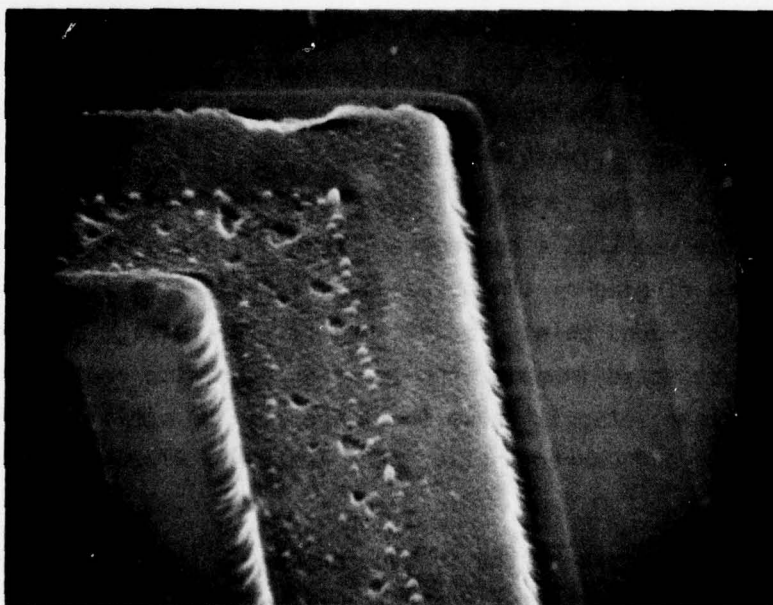
Figure 6. Examples of metallization microcracks at collector contact windows.

(This metallization crack over the collector oxide step is typical of all circuits in the cracked metal group.)

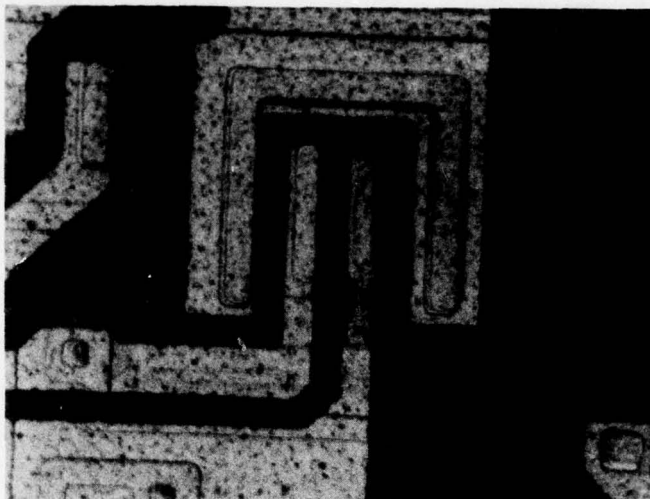
Figure 11a. Failure category I; arc-over between emitter and collector of output transistor.

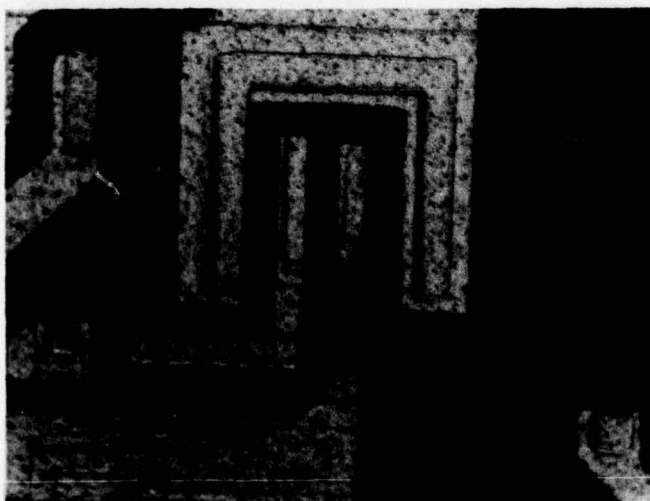
Figure 11b. Failure category II; change in appearance of emitter metallization due to heating.

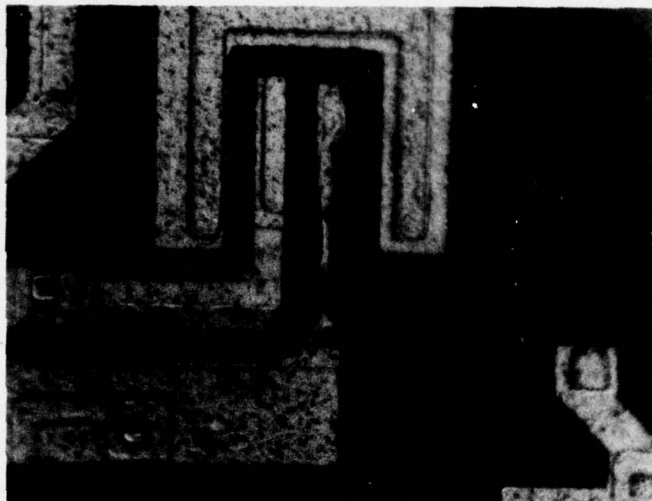
Figure 11c. Failure category III; obvious melting of emitter metallization stripe.

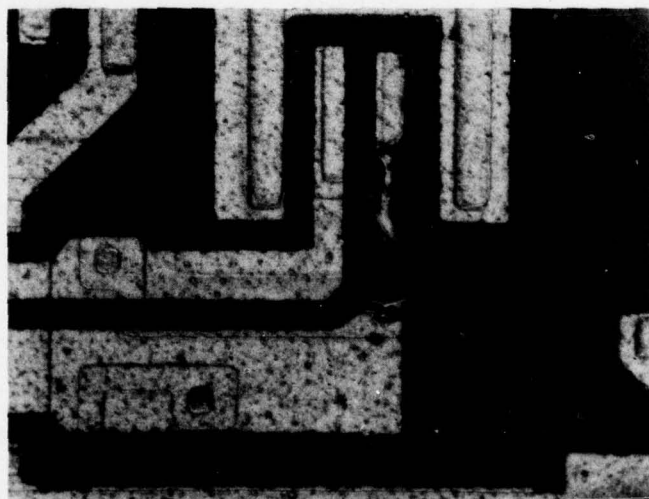
Figure 11d. Failure category IV; metallization burnout of emitter metallization stripe.

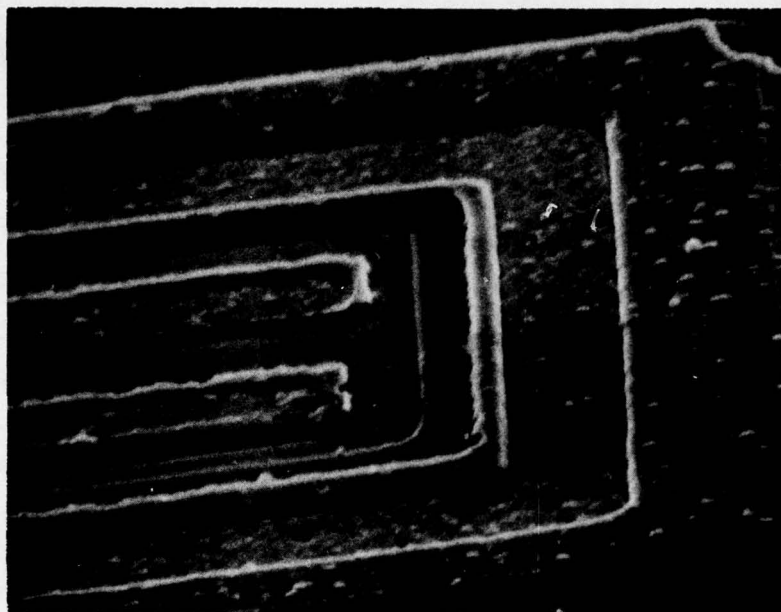
Figure 13a. Metallization microcrack at collector contact window after current pulsing.

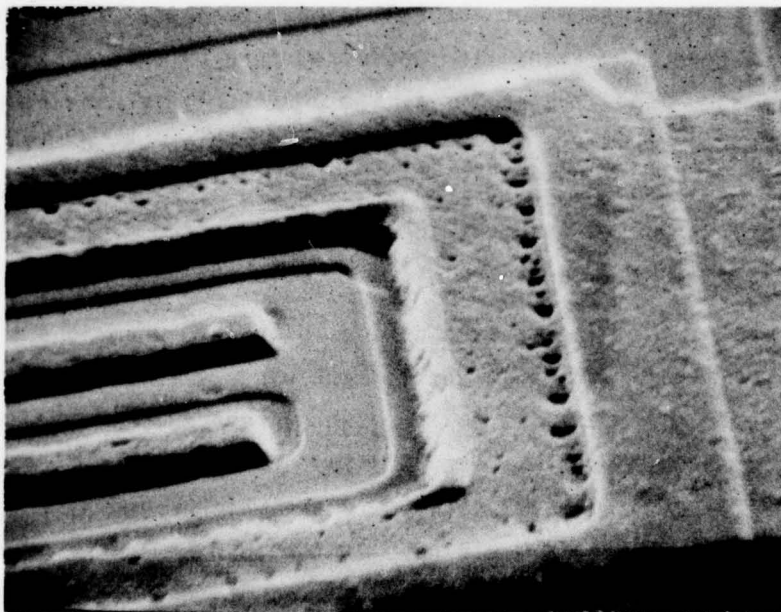
However, two of the microcracked devices displayed unambiguous microcracks in the collector metallization at the contact windows (Fig. 13b). These microcracks may have become opens due to the high current pulses. The important consideration in these cases was the relative cross sections of the emitter stripe and the collector metallization. If the thicknesses of both metallizations were identical, the collector would have at least 30 times the cross section of the emitter where each crosses an oxide step, due to the difference in the width of the metallization. Since the burnout current is proportional to the cross section of the metallization, the emitter stripe should have suffered MBO at a

Figure 13b. Metallization pitting at collector contact window after current pulsing.
